Technical Report No. 68.190.16.0708.01

Test subject: Product: Lite Deck
Type: TFR-CS122244

Test specification: Loading test according to the client's requirement.
Details see Clause 3.

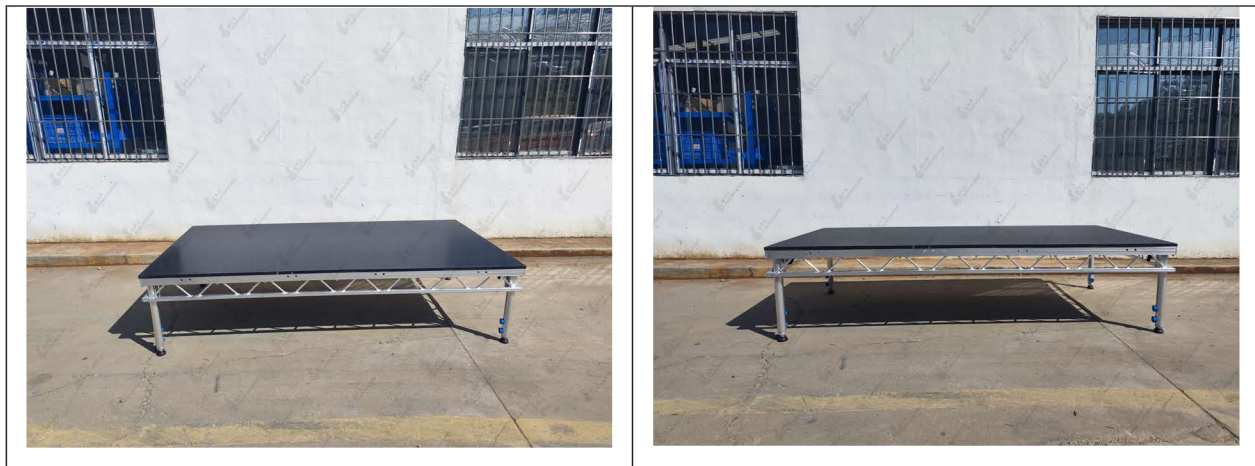
1.3 Product Photos

Dimension: 2440 mm x 1220 mm x 415~610 mm
Weight: 53,5 kg

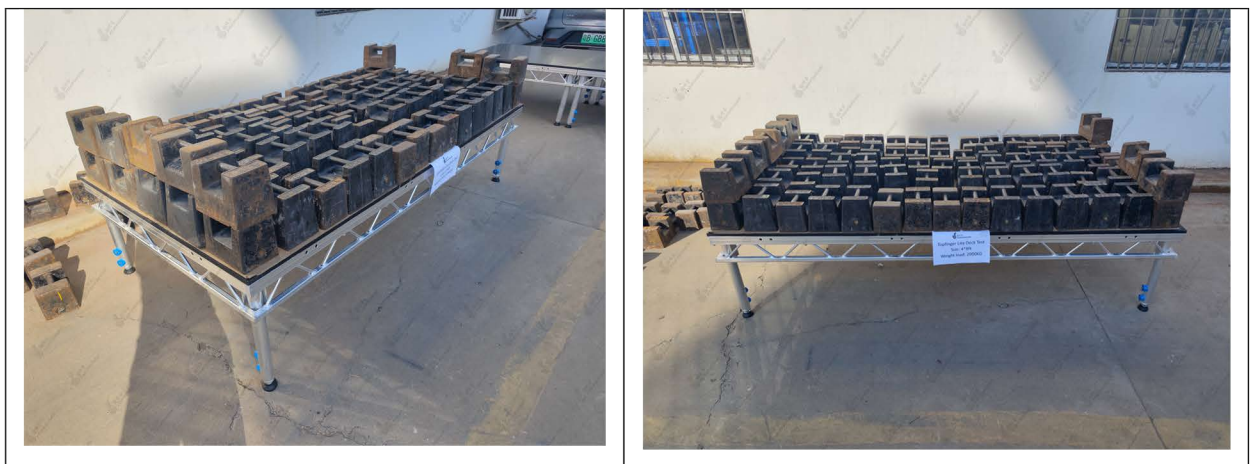
Test photos:

Verdict: P = passed; F = failed; NA = not applicable.			
Clause	Requirement Test	Remark	Verdict
1	<p>Loading test</p> <p>A tensile load F of 2700kg in vertical direction shall be applied uniformly to the sample for 1 hour according to the client's requirement.</p> <p>After removal of the test load, the sample shall not show any visible damages such as cracks, indentations etc.</p>	No visible damage was found after test.	P
